# **CITY OF SUNNY ISLES BEACH**

## **Feasibility Study Summary of a Bridge to Link a Pedestrian/Bicycle Greenway**

**Extension of North Bay Road from 172<sup>nd</sup> to 174<sup>th</sup> Street  
City of Sunny Isles Beach**

CGA Project No. 04-4567  
September 2004

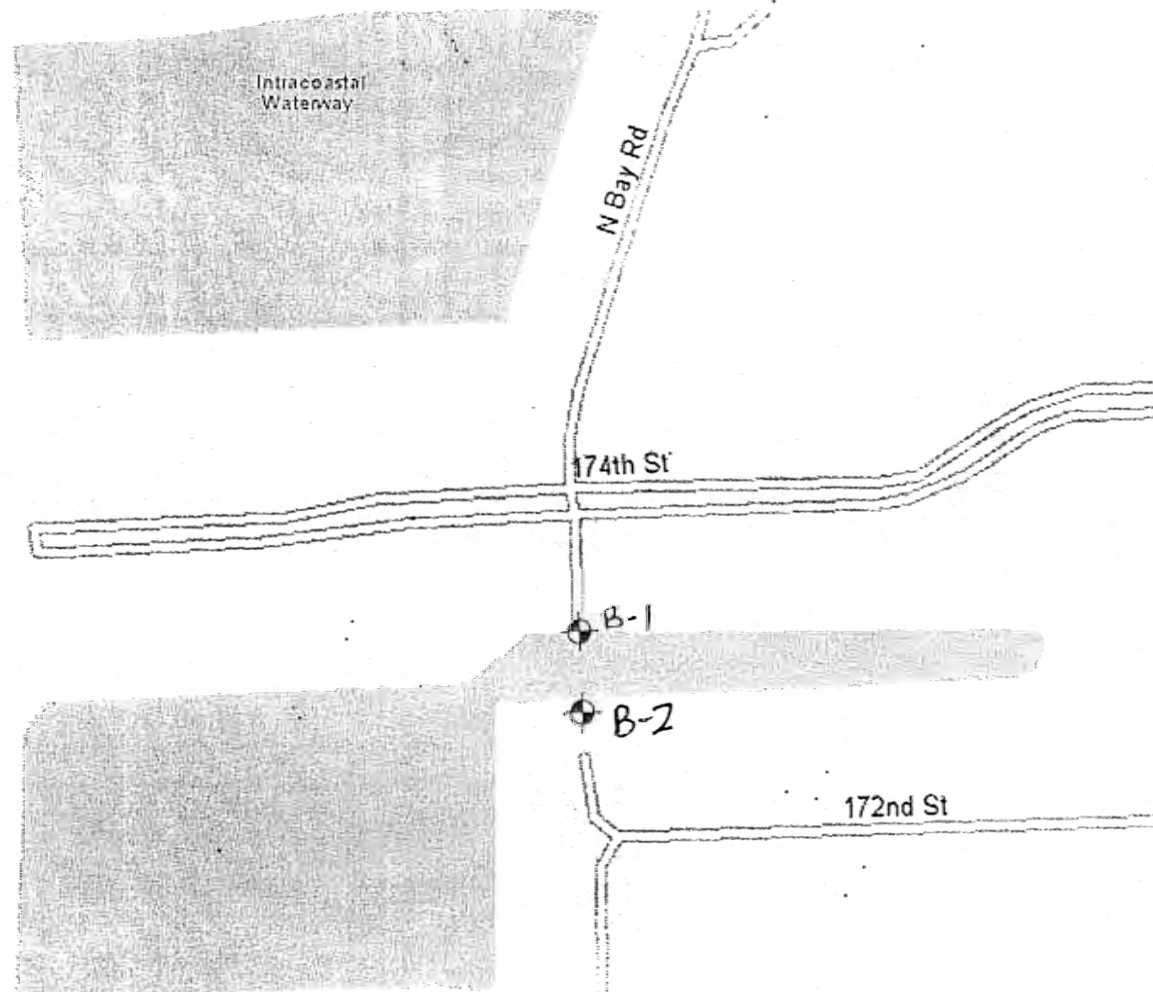
- LEGEND -  
● APPROXIMATE TEST  
BORING (SPT) LOCATION

Nutting Engineers of Florida, Inc. has performed a total of two (2) standard Penetration Test borings (ASTM D-1586) to depths of 50 feet below the existing ground surface in order to evaluate the subsurface soil conditions. The borings were performed along N. Bay Road, one on the north side and on the south side of the canal.

In addition, we performed corrosivity tests on each of the samples. The locations of the test borings are indicated on the attached Test Boring Location Plan. Individual test boring reports are presented in the Appendix of this report. The borings were established in the field using approximate methods; namely, a measuring wheel and available surface controls.

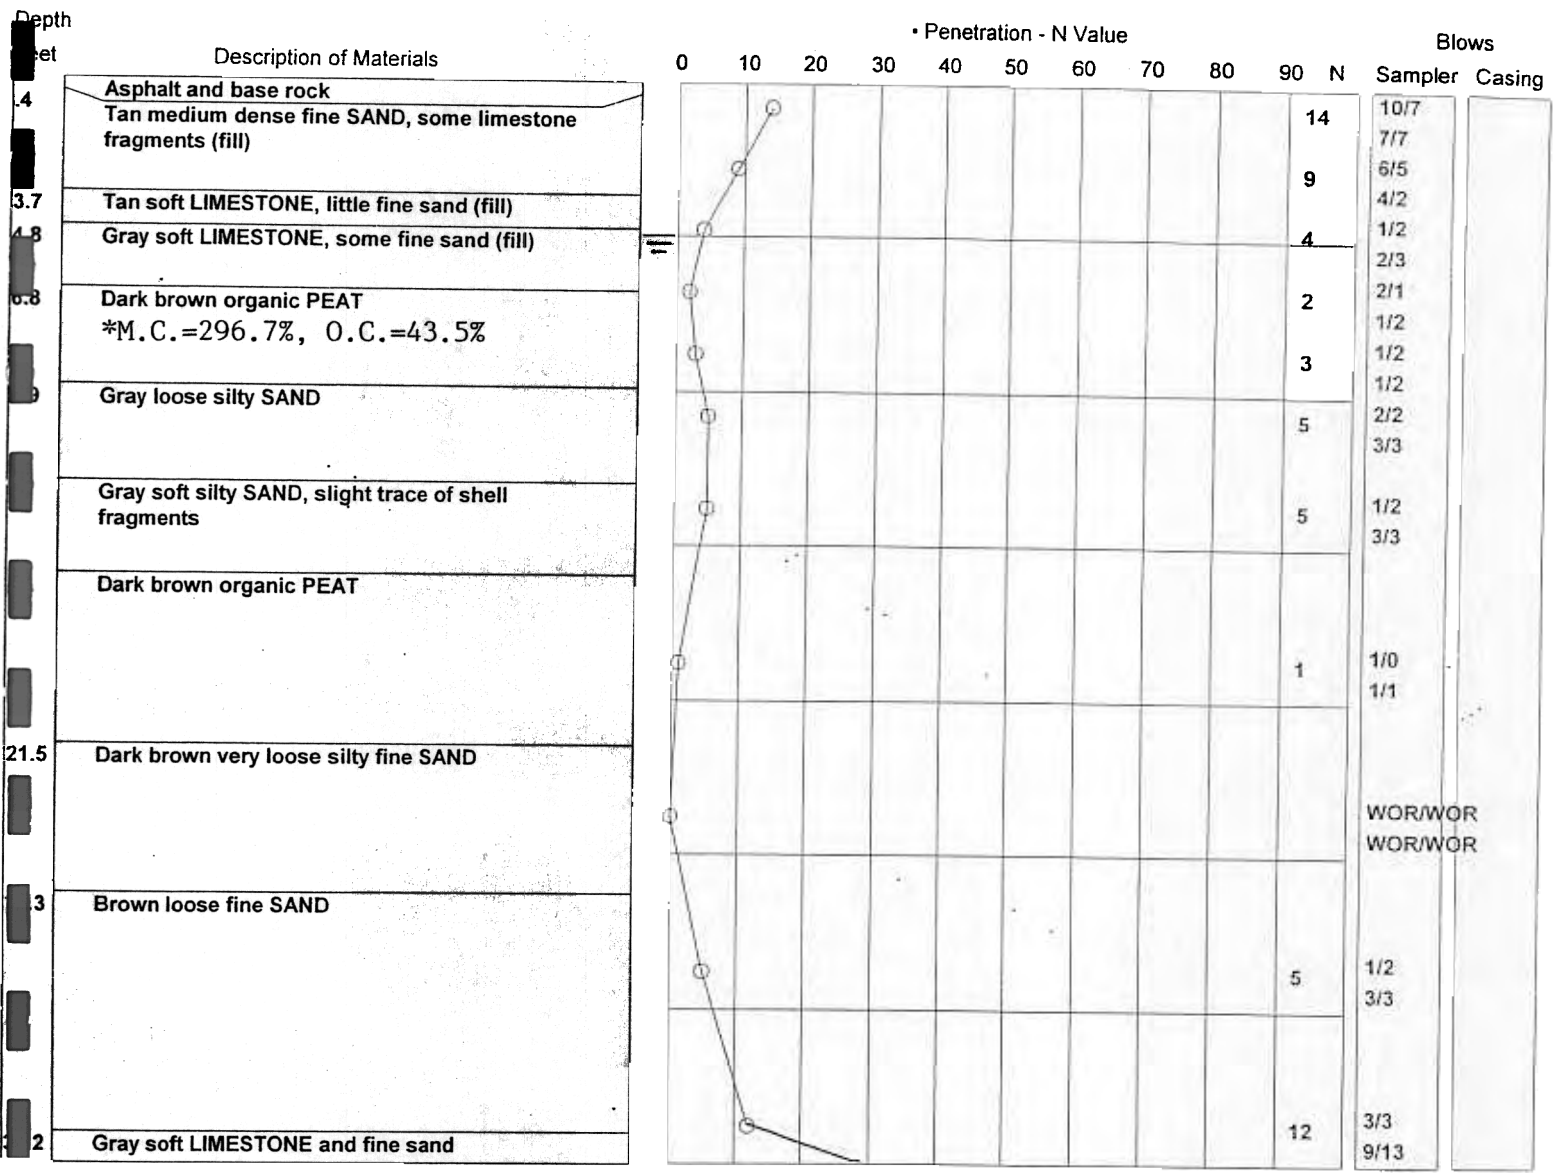
# TEST BORING REPORT

Client: Calvin, Giordano & Associates, Inc. Order #: 101.11  
 Project Name: Sunny Isles Beach Pedestrian / Emergency Vehicle Bridge Hole #:   
 Project Location: North Bay Road, Sunny Isles Beach, FL  
 Hole Location: Approx. 10' E. of mark on Site  
 Driller: T. Simmons Date Started: 2/12/04  
 Elevation Reference: Approx. @ Road Crown Date Completed: 2/12/04  
 Casing Diameter: 3" OD BX Flush Couple Hammer WT: 280# Fall: 24"  
 Sampler Diameter: 2" OD x 2' Split Spoon Hammer WT: 140# Fall: 30"  
 Groundwater depth: Immediate: 5'

Based on the SPT borings, the generalized subsurface conditions consist of seven main strata encountered below the asphalt and topsoil layer encountered in boring B-1 and B-2 respectively. Following describes each stratum.

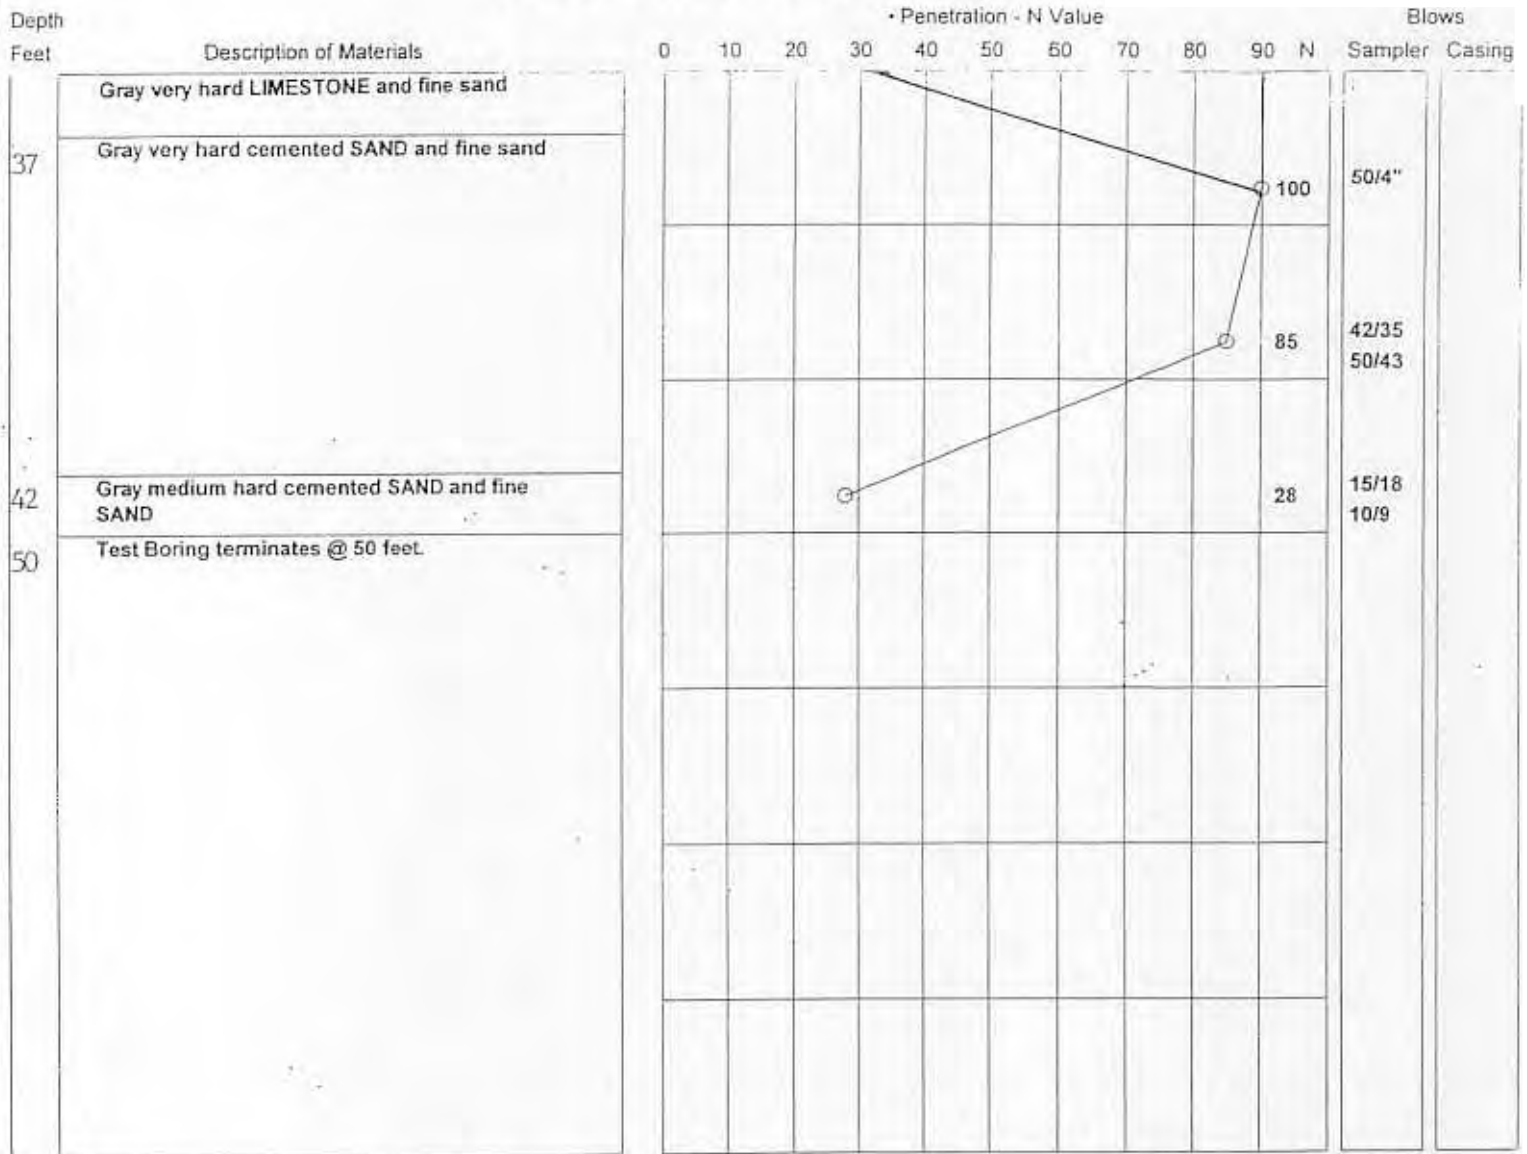
## TEST BORING REPORT

Client:	Calvin, Giordano & Associates, Inc.	Order #:	101.11
Project Name:	Sunny Isles Beach Pedestrian / Emergency Vehicle Bridge	Hole #:	2 of 2
Project Location:	North Bay Road, Sunny Isles Beach, FL		
Hole Location:	Approx. 40' N. and 35' W. of the NE Building Corner @ 17150		
Driller:	T. Simmons	Date Started:	2/12/04
Elevation Reference:	Approx. @ Road Crown	Date Completed:	2/12/04
Casing Diameter:	3" OD BX Flush Couple	Hammer WT:	280# Fall: 24"
Sampler Diameter:	2" OD x 2' Split Spoon	Hammer WT:	140# Fall: 30"
Groundwater depth:	Immediate: 5'

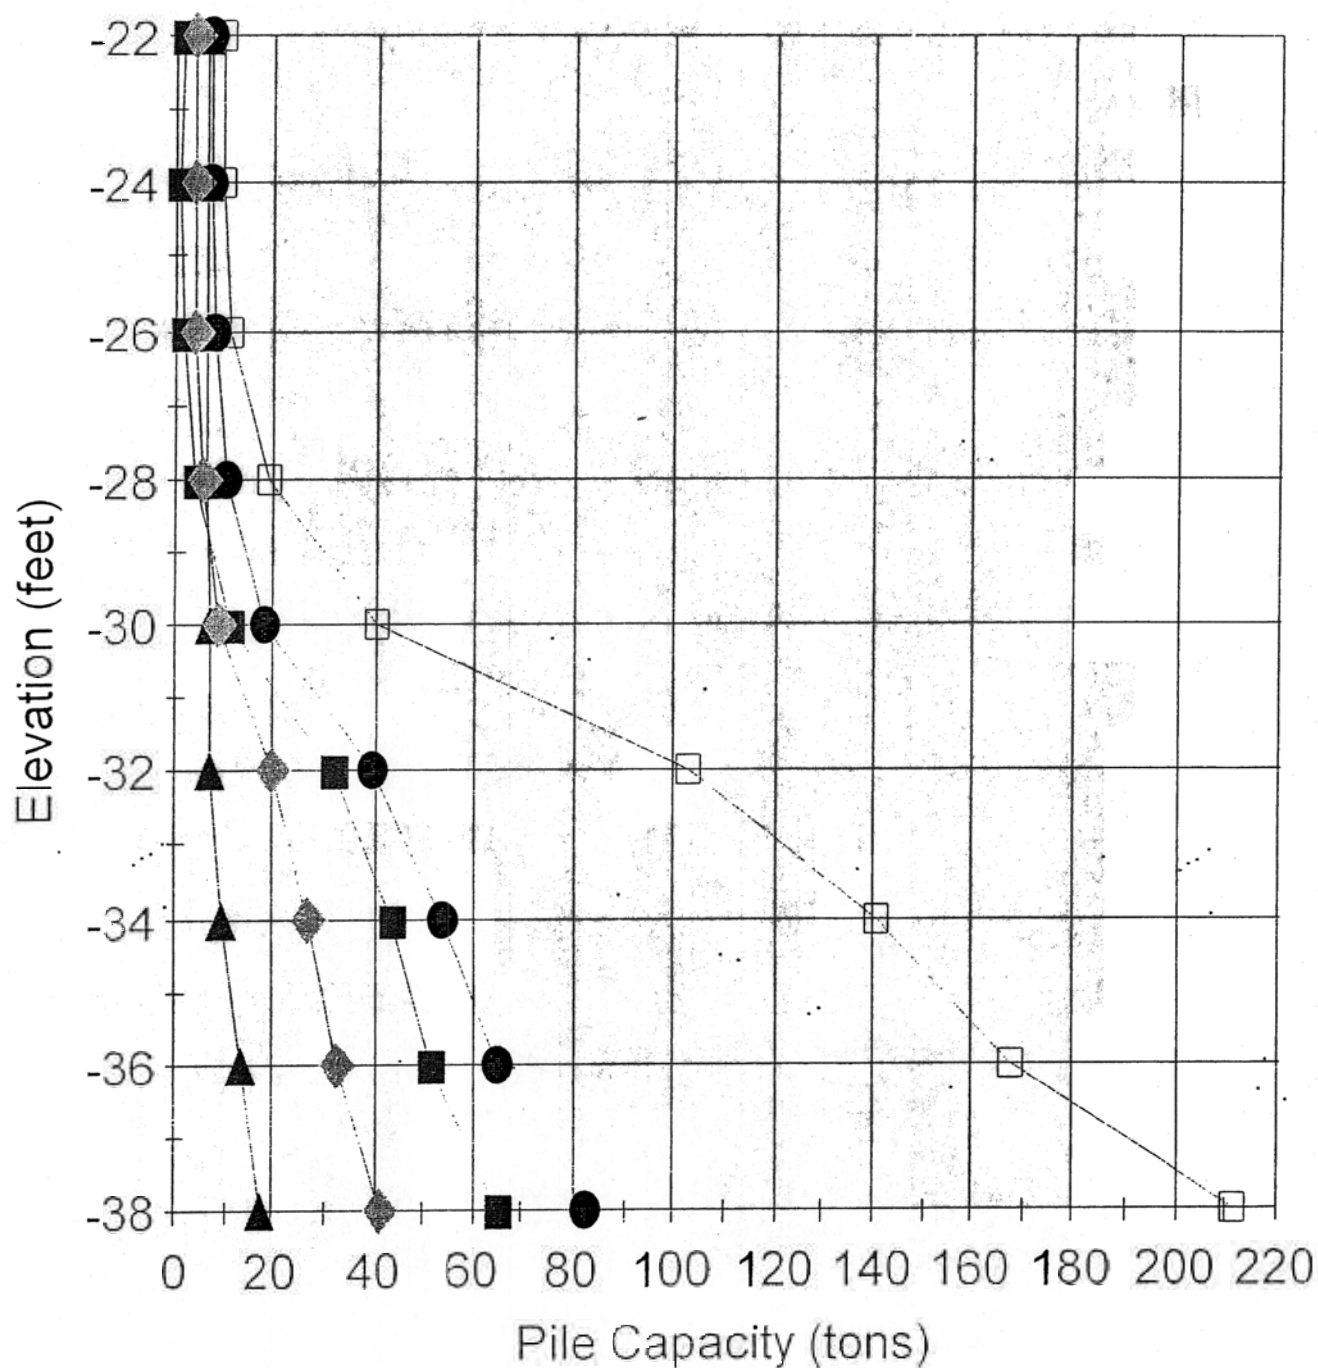
# Pile Capacities for Pile Width of 4.00 in

- ▲ Ultimate Side Friction
- Mobilized End Bearing
- Estimated Davisson Capacity
- Allowable Pile Capacity
- Ultimate Pile Capacity

Our analysis indicates that 14 inch by 14 inch square precast concrete piles driven into the well cemented limestone will provide an allowable compressive capacity of 35 tons. This translates to pile lengths ranging from 38 to 39 feet below the existing ground surface. The actual depths should be expected to vary depending on the driving conditions encountered during installation of these piles. This is based on the borings and our experience in the area. If lateral loads are involved, we should be notified to evaluate this condition.

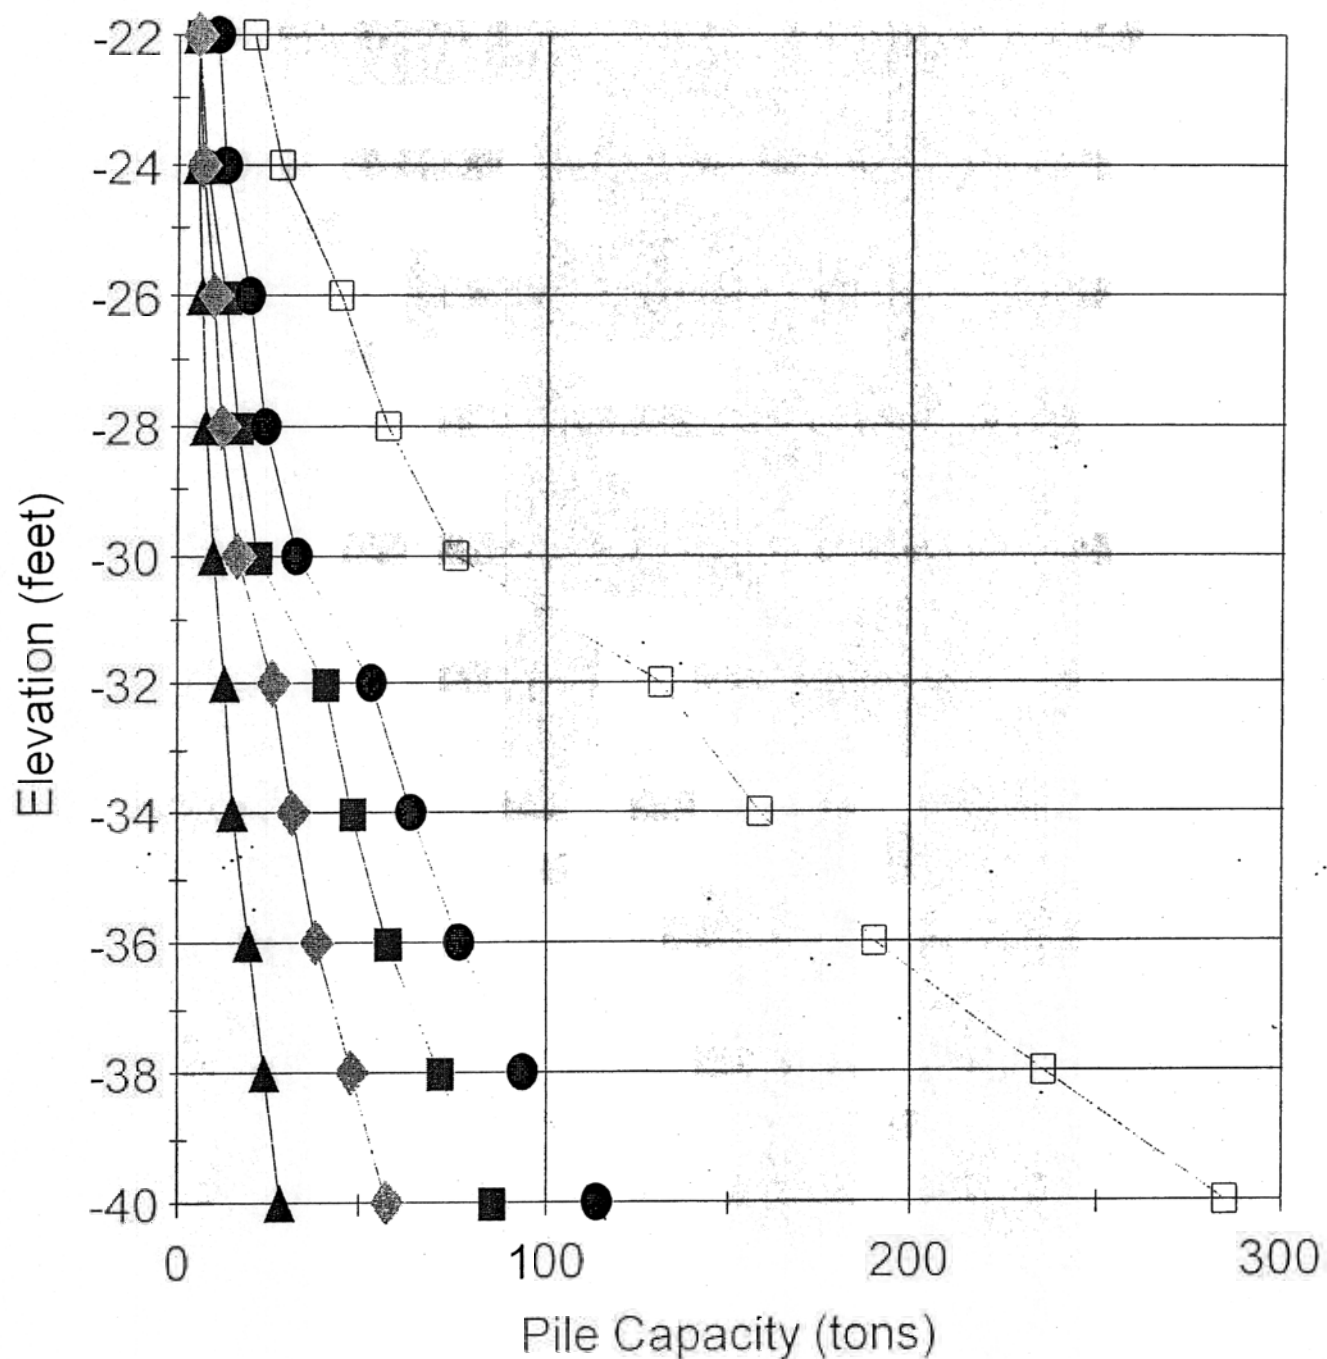
# Pile Capacities for Pile Width of 4.00 in

- ▲ Ultimate Side Friction
- Mobilized End Bearing
- Estimated Davisson Capacity
- Allowable Pile Capacity
- Ultimate Pile Capacity

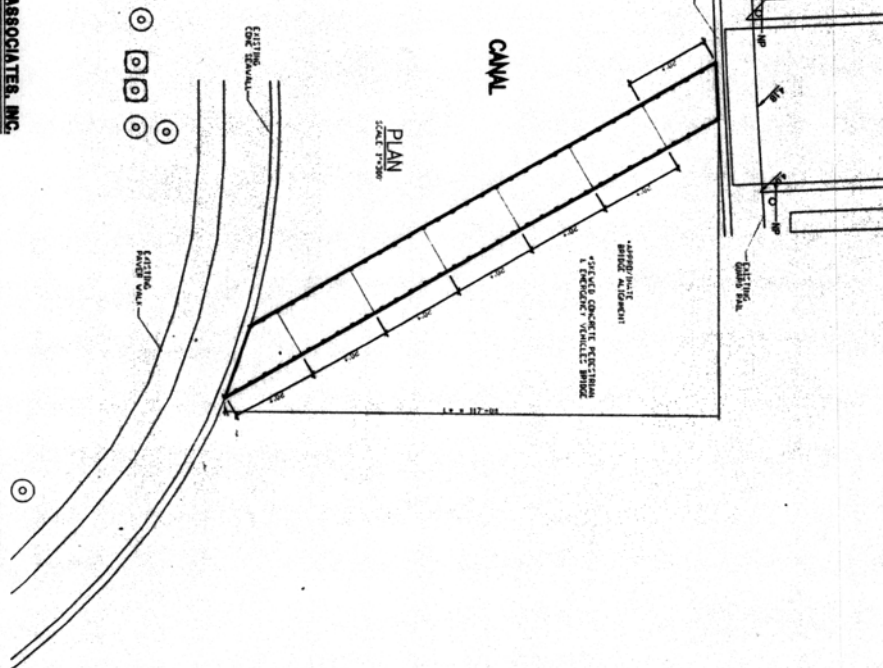
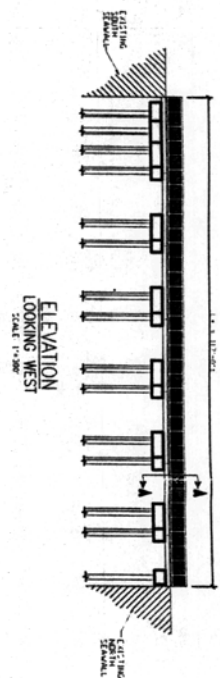
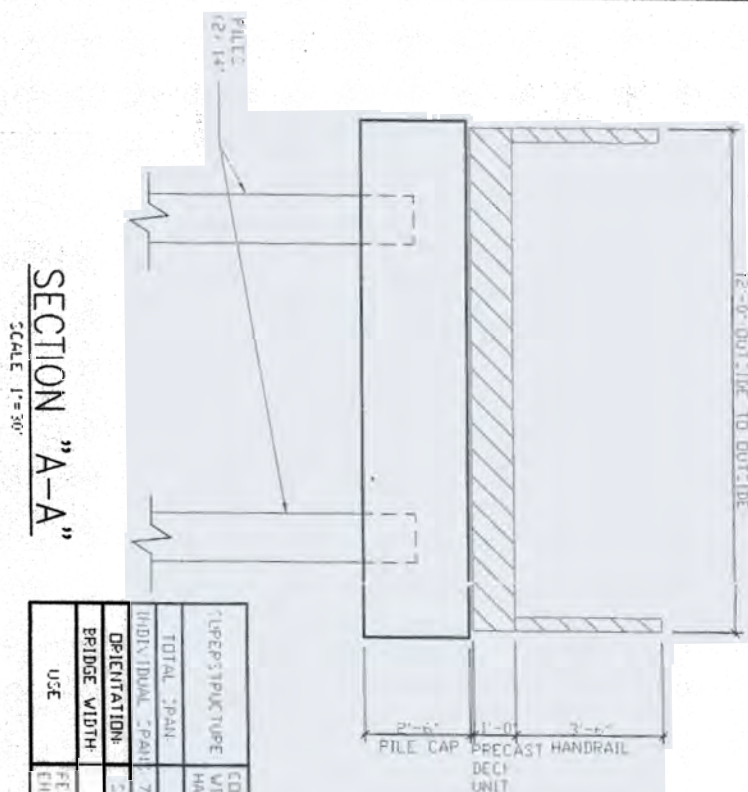
SECTION "A-A"

TYPE/STRUCTURE TYPE	CONCRETE DECKS WITH ALUMINUM HANDRAILS
TOTAL SPAN	140 LF ±
INDIVIDUAL SPAN	7 @ 20 LF ±
ORIENTATION	WEAVED 30° ±
PERIODE WIDTH	12" ±
USE	RECREATION & FITNESS CENTER

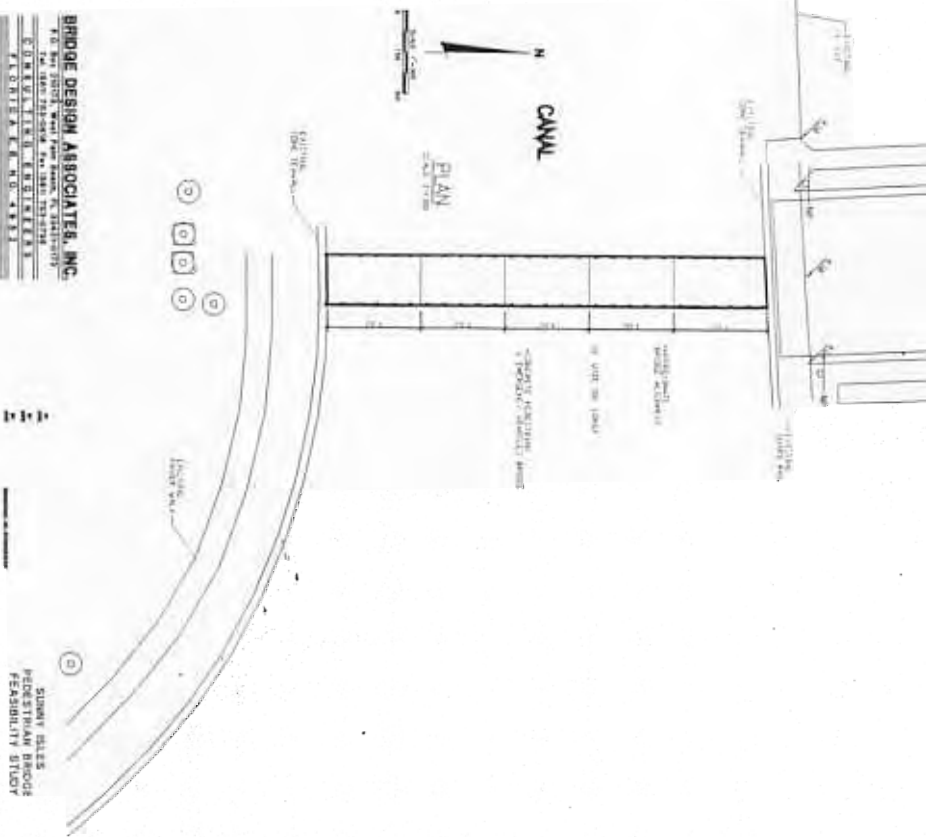
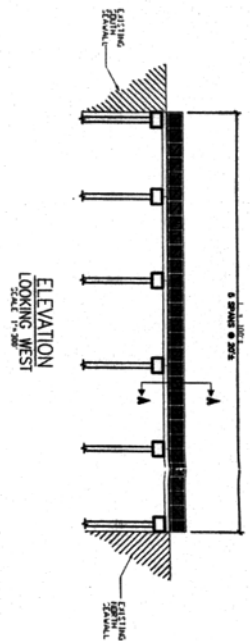
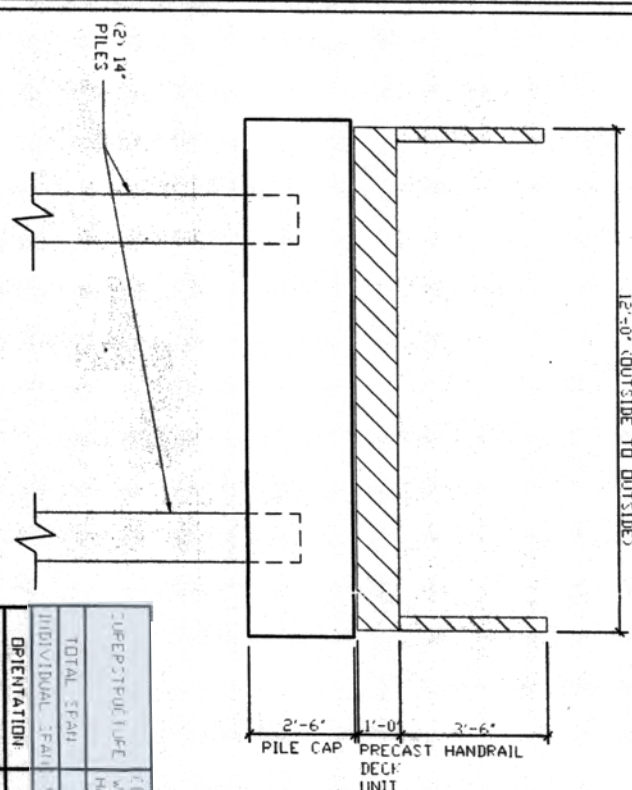
SECTION "A-A"  
 SCALE: 1"=30'

CONCRETE DECKS WITH ALUMINUM HANDRAILS	CONCRETE DECKS WITH ALUMINUM HANDRAILS
TOTAL SPAN	100 L.F. ±
INDIVIDUAL SPAN	5 @ 20 L.F. ±
ORIENTATION	STRAIGHT
BRIDGE WIDTH	12' ±
USE	PEDESTRIAN & LIGHT VEHICLE

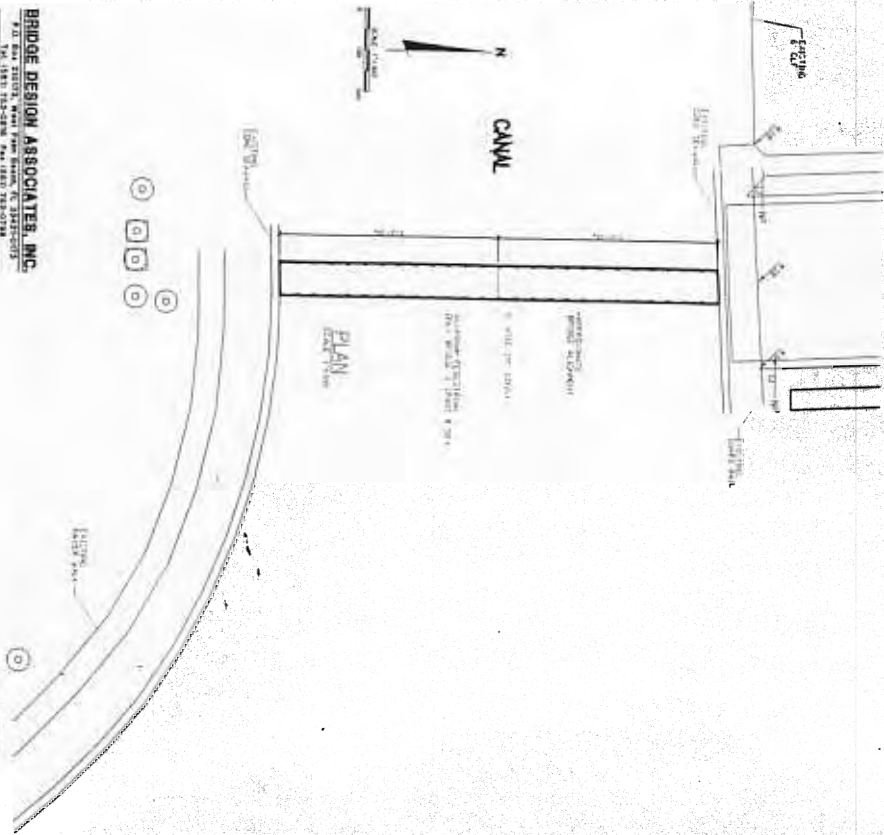
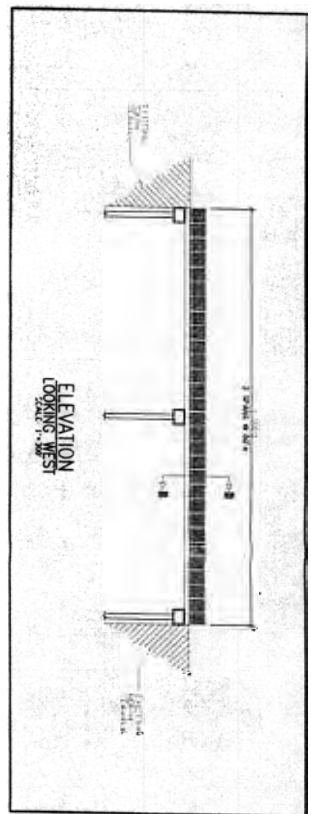
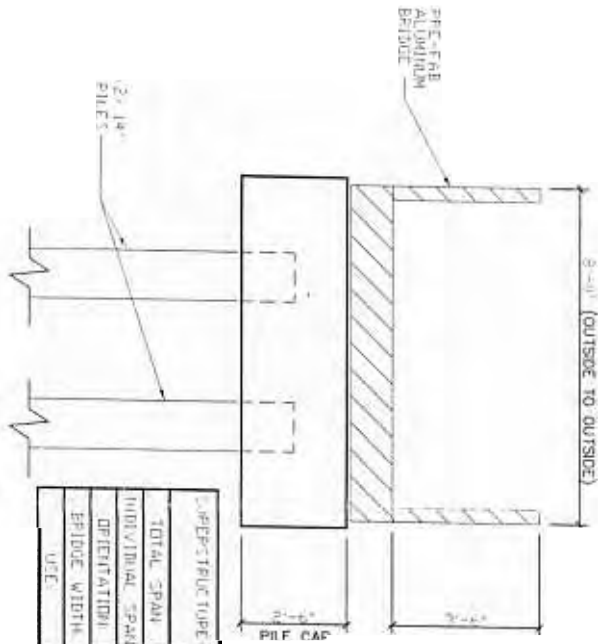
PEDESTRIAN TYPE	ALUMINUM DECK
TOTAL SPAN	100 L.F.
INDIVIDUAL SPAN	2 @ 50 L.F.
ORIENTATION	STRAIGHT
BRIDGE WIDTH	8'-6"
USE	PEDESTRIAN ONLY

Maps and survey data were used to project possible alignment of the proposed bridge (see Appendix C, Figure 1). Feasibility study for structural analysis was performed by Bridge Design Associates, Inc. to determine the placement and costs of the proposed bridge. It was recommended that the bridge should have a concrete substructure with an aluminum or concrete superstructure, due to the corrosivity of the soil. The use of an aluminum superstructure is for pedestrian access only, while the concrete superstructure is for both pedestrian and emergency access. Four possible design alternatives were proposed (see Appendix C, *Design Alternatives*). Option 1 has pedestrian/emergency vehicle capability with a skewed orientation, a total span of 140 feet, 7 spans at 20 feet, and an estimated cost of \$1,400,000. Option 2 has a pedestrian/emergency vehicle capability at a straight orientation with a total span of 100 ft, 5 spans at 20 ft, and an estimated cost of \$1,330,000. Option 3 has pedestrian access only, with a skewed orientation, a total span of 140 ft, 3 spans at 47 feet, and an estimated cost of \$1,310,000. Option 4 has pedestrian access only, a straight orientation, a total span of 100 feet, 2 spans at 50 feet, and an estimated cost of \$1,230,000.
